## A9 Cromarty Phase 2 Refurbishment

A9 1360 Cromarty Bridge, Scotland

**Client**  
Transport Scotland  
**Principal Contractor**  
BEAR Scotland  
**Designer**  
Jacobs  
**Works Commenced**  
September 2017  
**Works Completed**  
April 2018

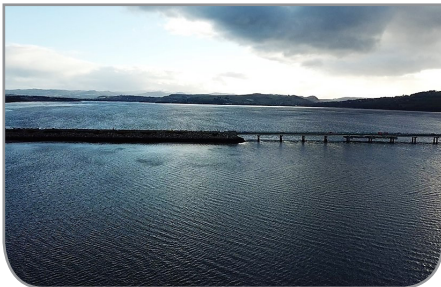
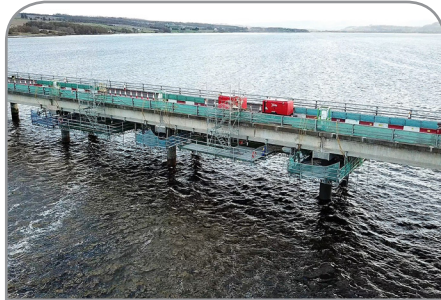
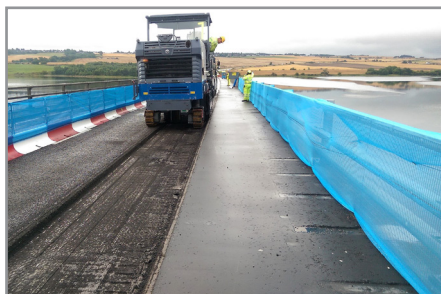
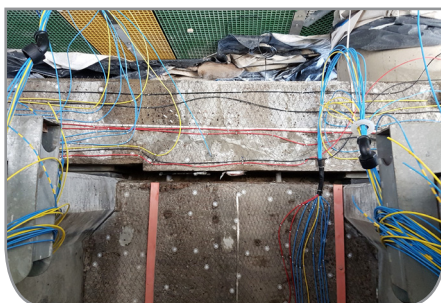
The A9 Cromarty Bridge opened in 1979, measuring 1464 metres and comprising of 68 simply supported spans. Essential maintenance repairs were required to the structure including concrete repairs, cathodic protection and expansion joint replacement.

Freyssinet installed a bespoke suspended platform suitable for work in marine environment to enable the structural repair works, hydrodemolition and installation of the cathodic protection system.

The platform contained the debris and contaminated water, with the water continuously pumped out onto the top of the bridge deck and treated prior to being transported and discharged into a licensed waste location.

An electric hoist was also used to remove and bring up debris contained in the platform to the top of the bridge deck.
